# Memo

Re: **Response to December 31, 2021 Peer Review Letter from Henry Nover, PE**  
Notice of Intent Supplemental Documentation (DEP File # 273-0408) Submittal  
Shingle Mill Multi-Family Development, 0 Pond Street, Rockland, MA

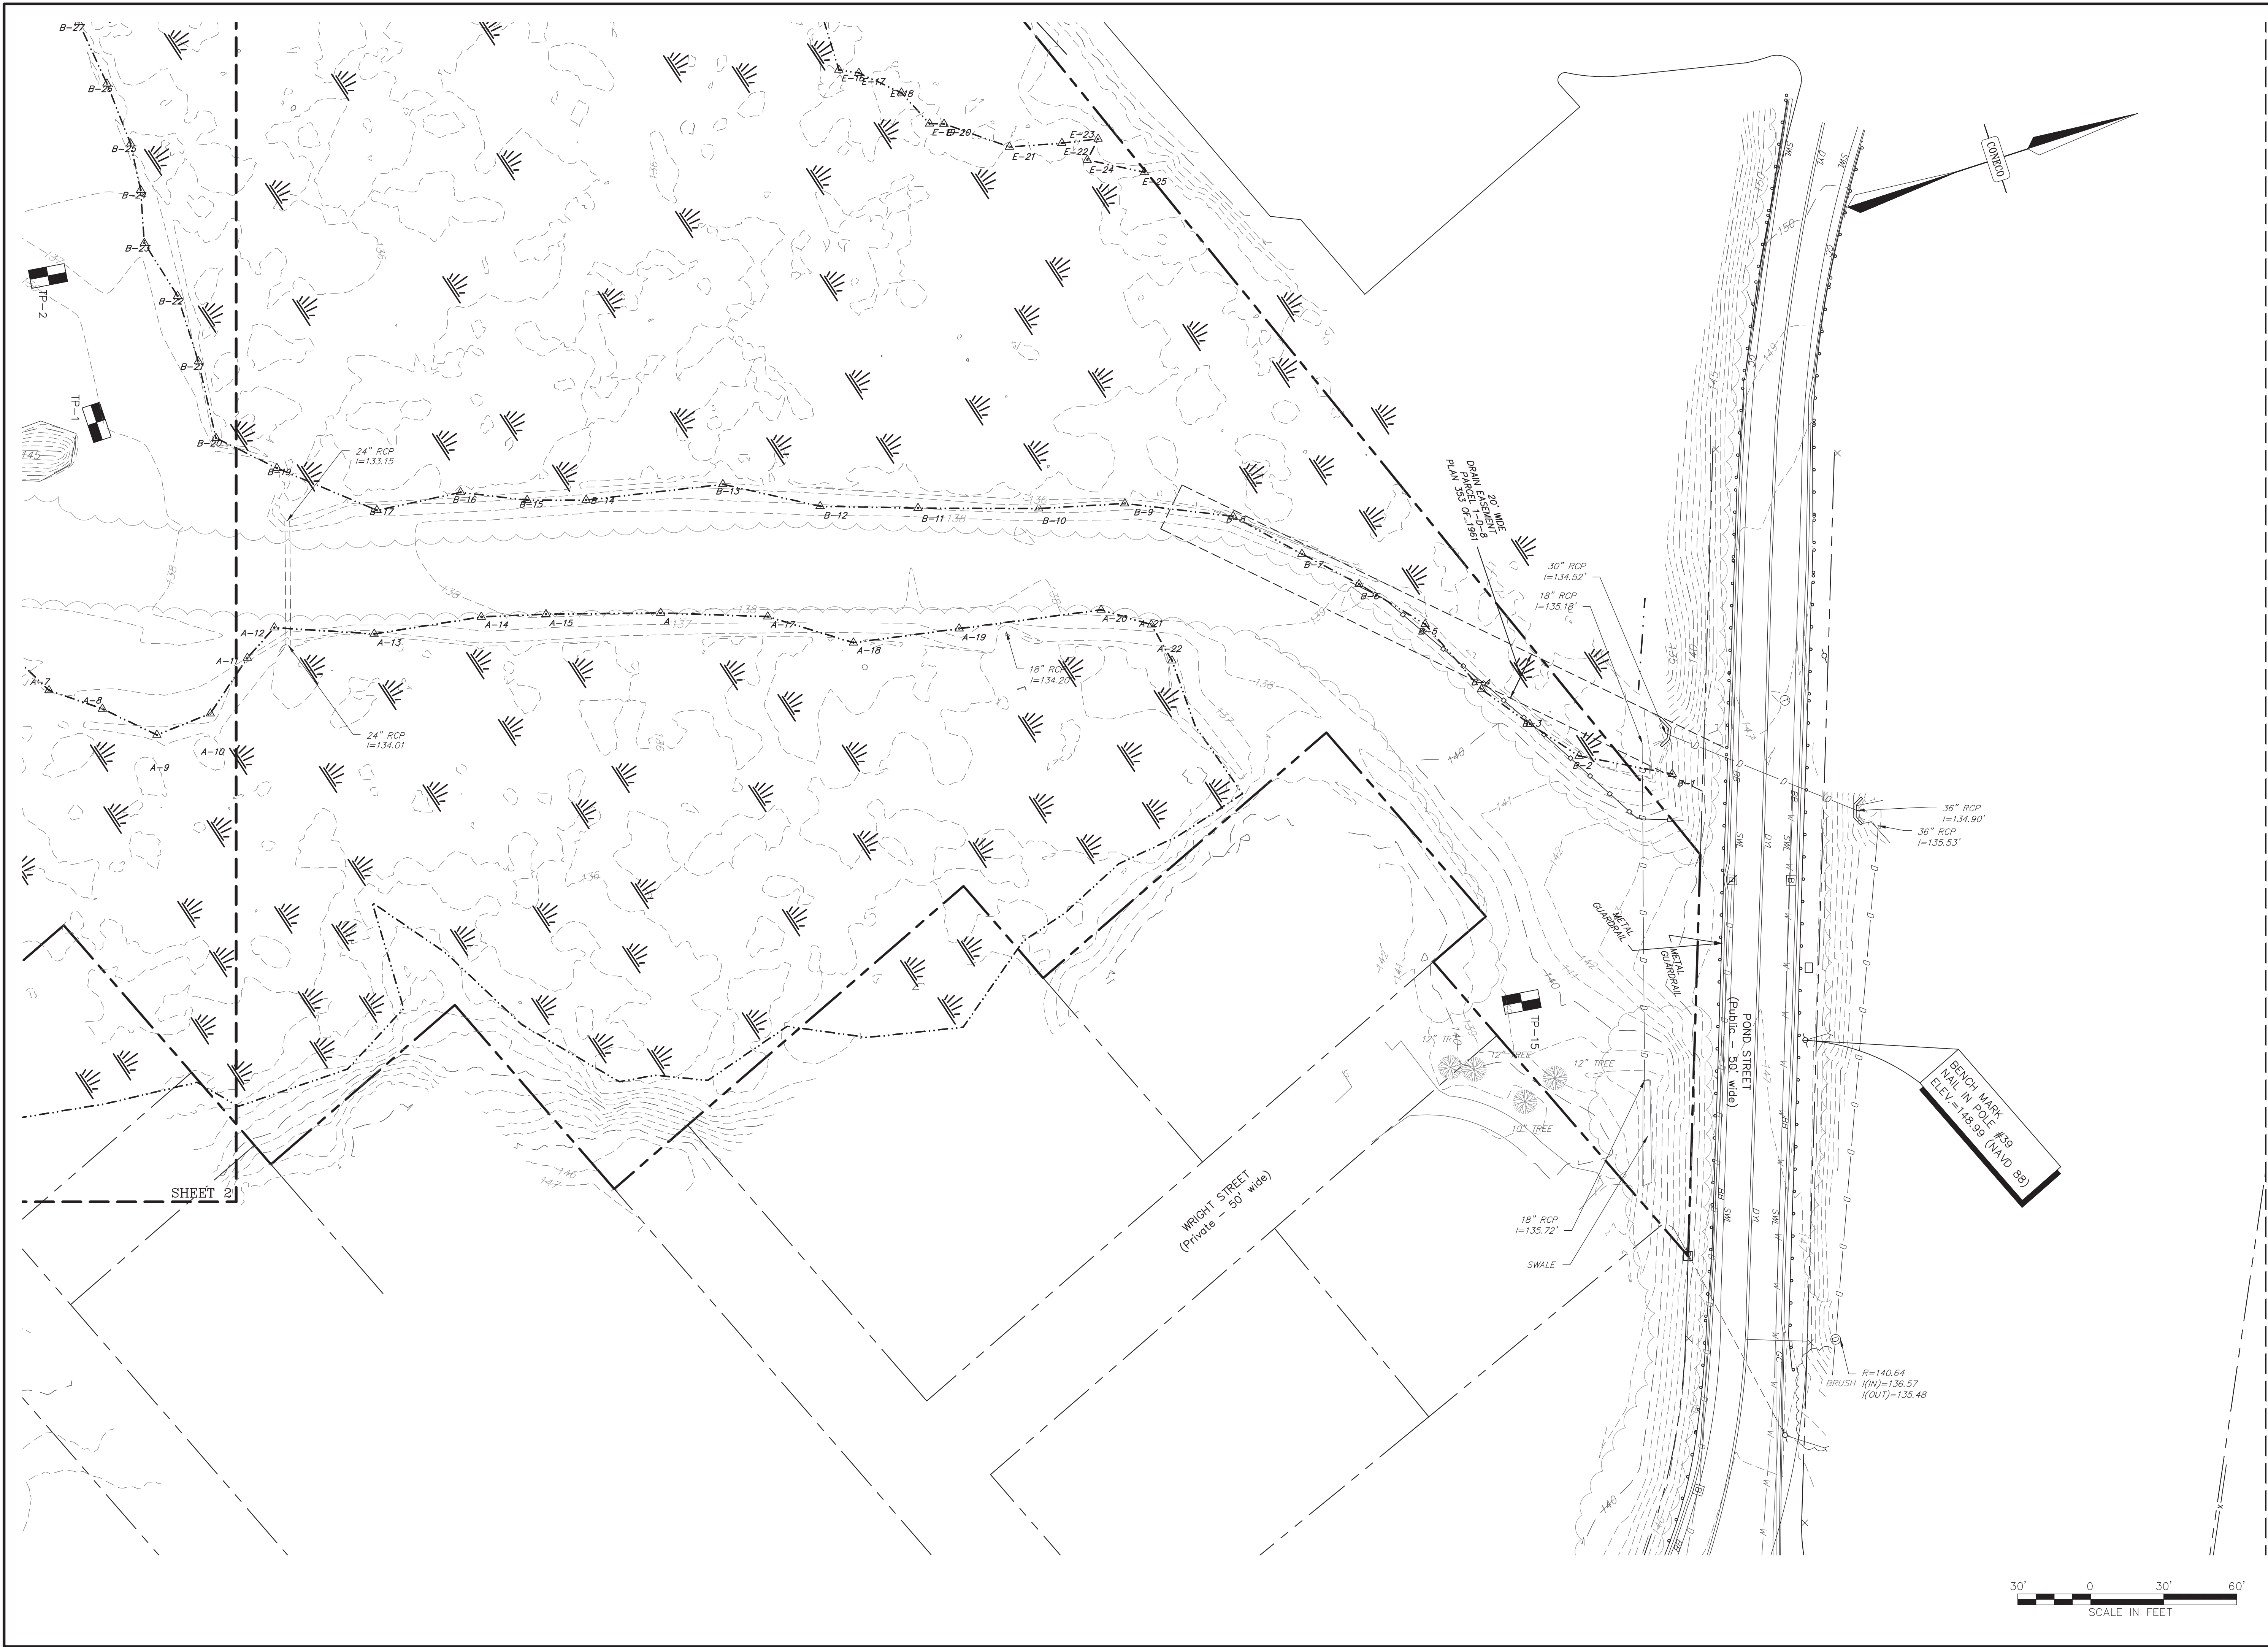
Driveway sections on sheets C-202 thru C-208 depict the approximate limits of the buried depth of the walls and leveling pads for the retaining walls along the driveway. In addition, a Temporary Wetland Impact Exhibit is enclosed depicting the areas  $\pm 5'$  off the edge of leveling pad that may result in temporary impacts to the Bordering Vegetated Wetlands. Landscaping plans will be provided in the future and will include restoration measures for these locations.
